# KRAKOWSKA 57

Property profile and historically informed visual reconstruction

Parcel: 260801\_4.0001.388 Town: Działoszyce, Poland

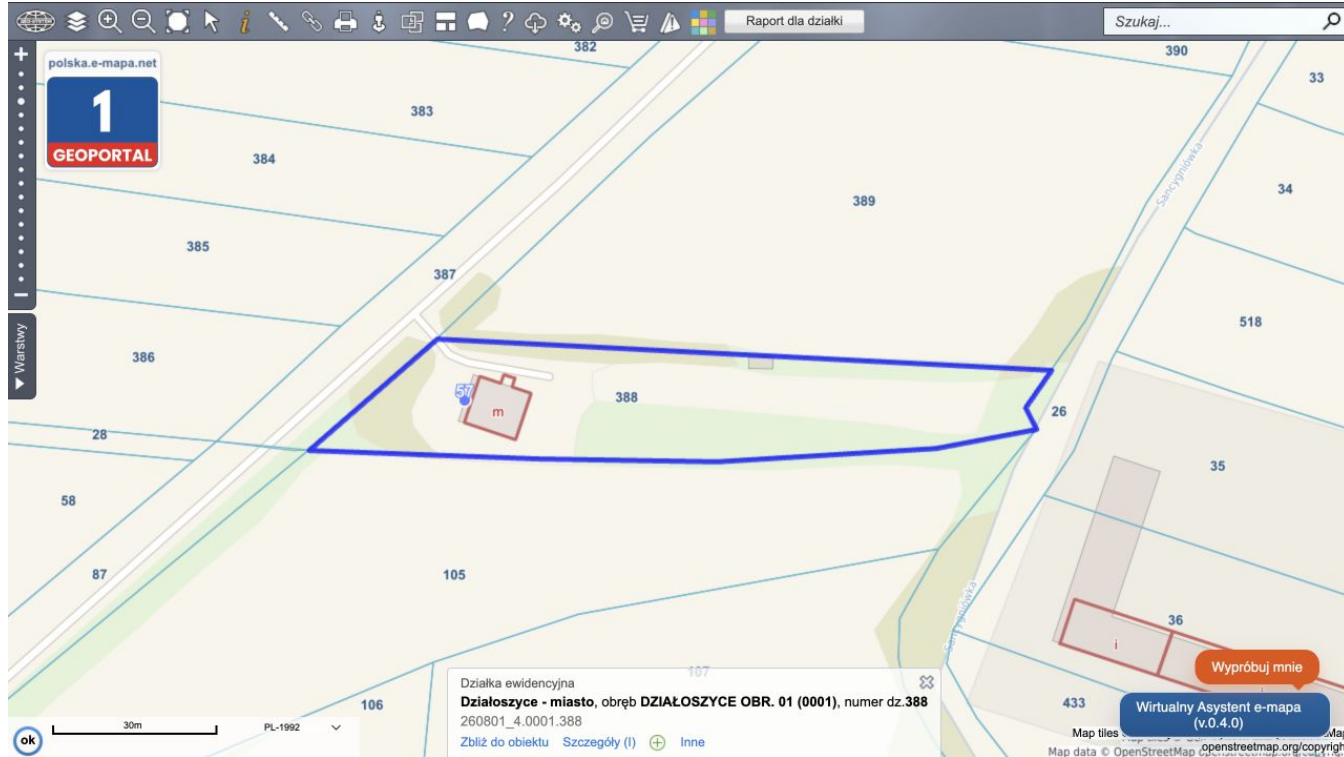
### ACTUAL SOURCE IMAGE

Official-style cadastral map view from e-mapa. The blue outline identifies parcel 388. This is the strongest available source for the parcel shape.  
Source: [polska.e-mapa.net/?identifyParcel=260801\\_4.0001.388](https://polska.e-mapa.net/?identifyParcel=260801_4.0001.388)

The parcel is long and narrow, extending from the house near Krakowska toward Sancygniówka. Boundary positions shown by the public map are informative, but legal boundary determination requires official survey documentation.

Because an AI image tool was used to align the shape, the line may not coincide precisely with surveyed coordinates. The cadastral map on page 3 should be treated as the controlling visual source in this report.

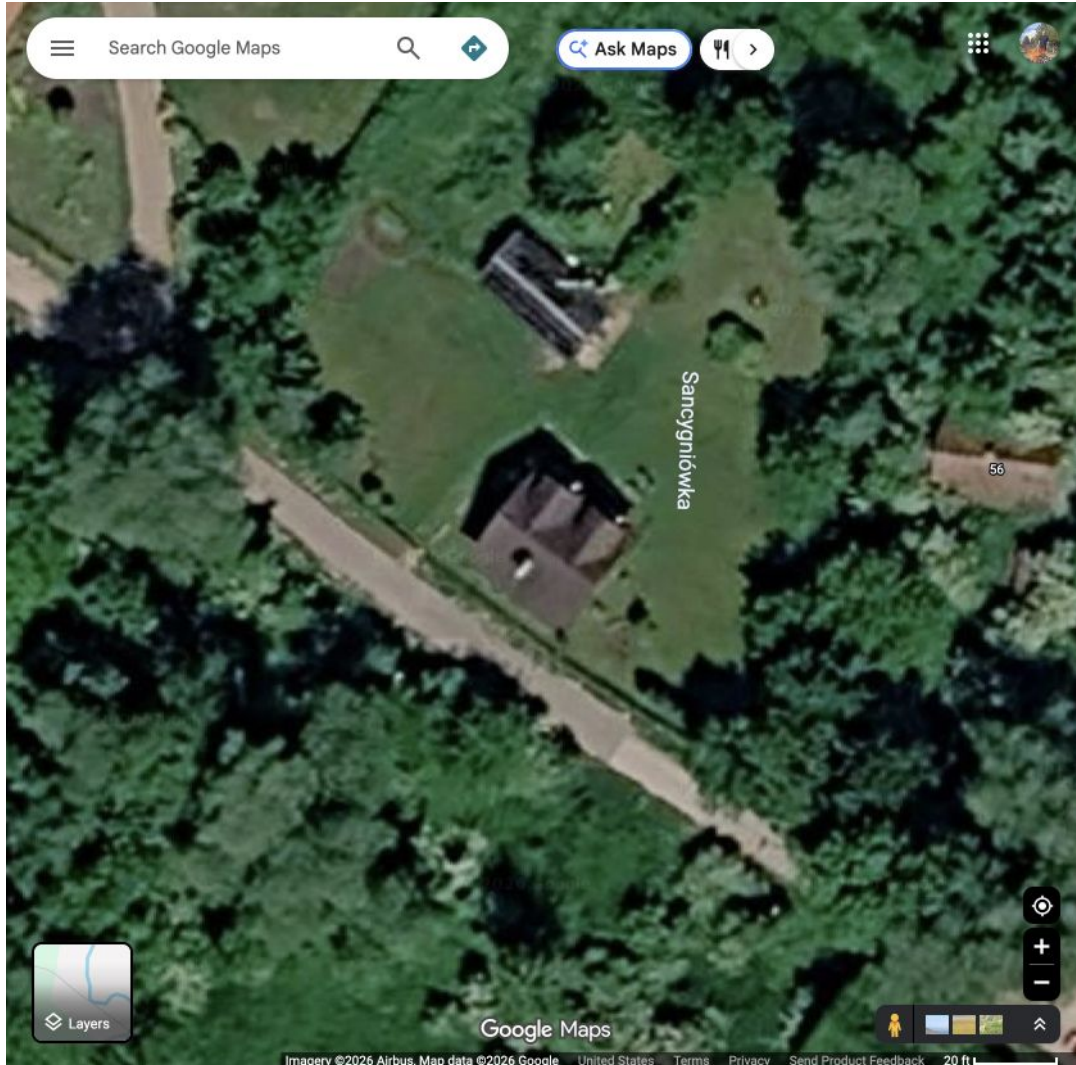
#### ACTUAL SOURCE IMAGE

Google Maps satellite screenshot centered on the property. The central L-shaped roof form is associated with number 57. Imagery attribution remains visible in the screenshot.

Visible features include a compact L-shaped main building, mature trees, open grass, a secondary structure farther north, and road frontage along the diagonal roadway.

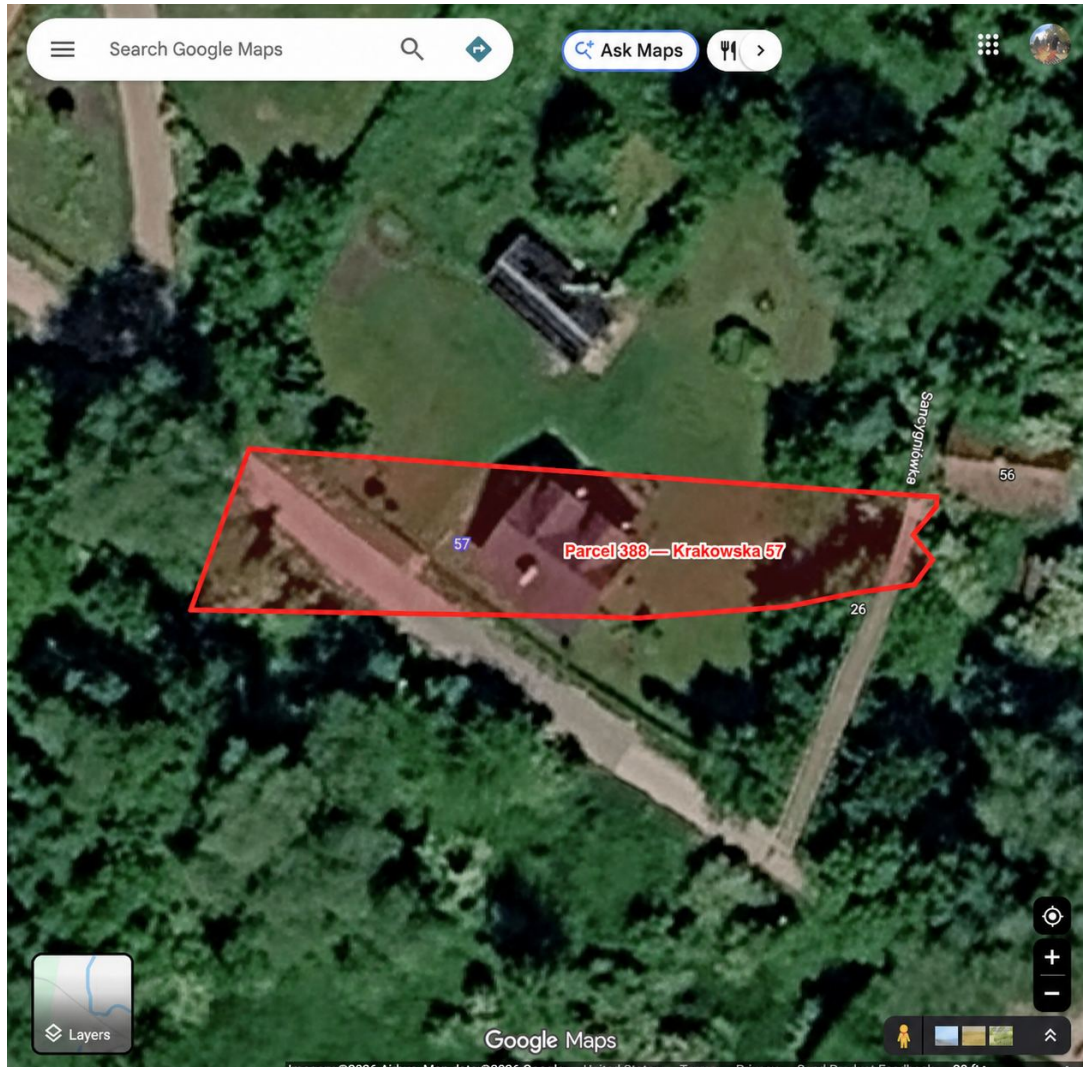
AI-ASSISTED VISUAL OVERLAY - NOT A SURVEY

AI-assisted transfer of the cadastral polygon onto the aerial image. This is an approximate explanatory overlay and must not be used for construction, conveyancing, fencing, valuation, or a boundary dispute.

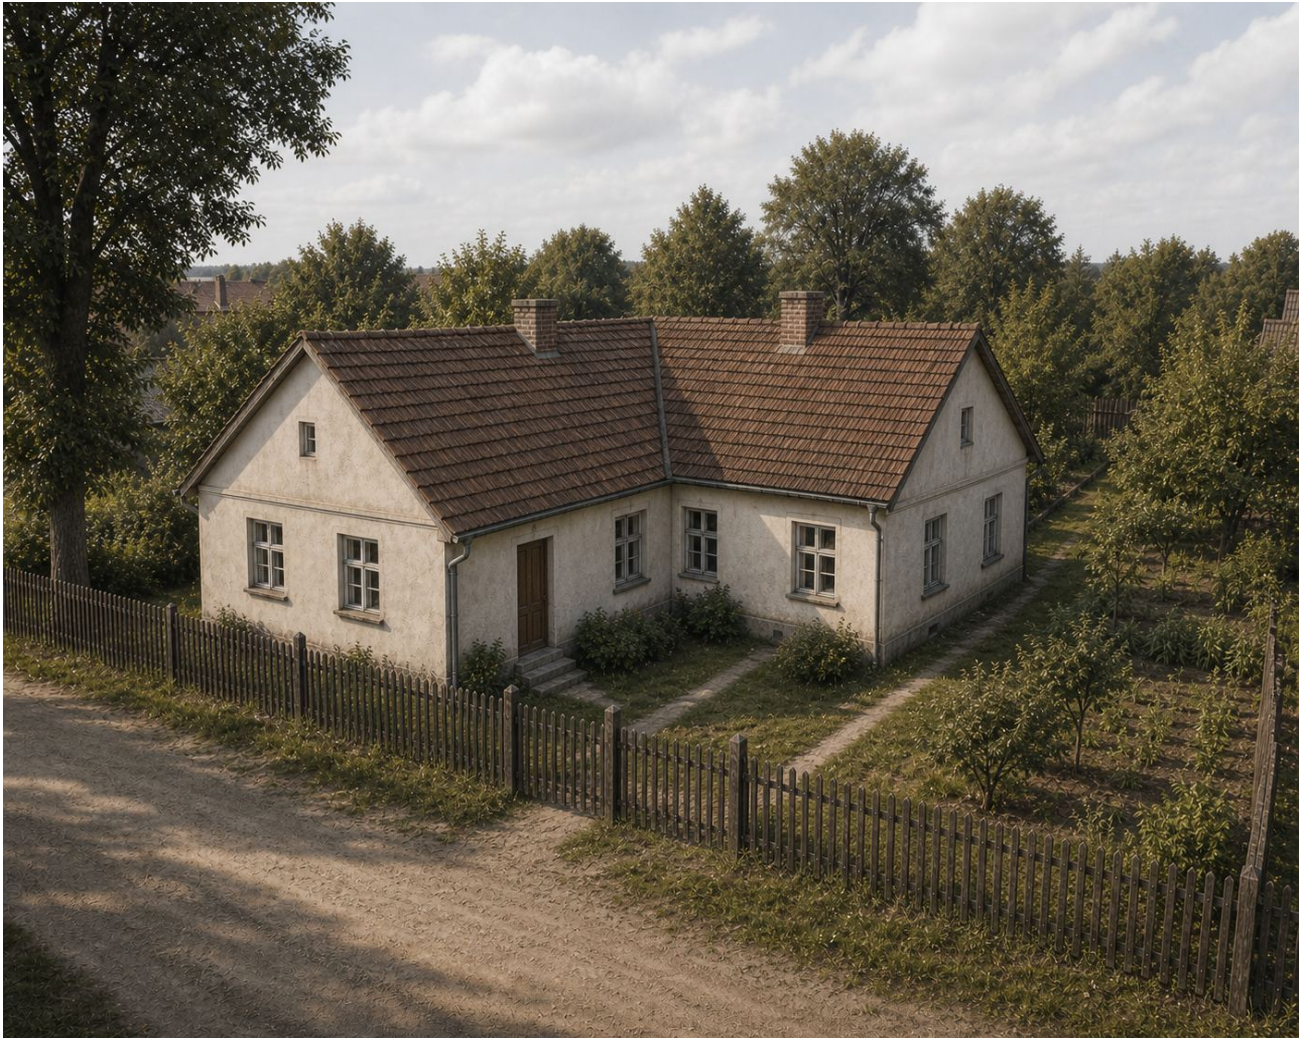
### AI-GENERATED CONJECTURAL RECONSTRUCTION

Revised conjectural rendering showing the recorded four-room house and three-room masonry section as connected or closely adjoining volumes. The second section is positioned beside and slightly behind the original, producing an L-shaped compound consistent with the present overhead roof form.

The exact original construction date is unknown. Positioning the second structure as a connected side wing is an interpretation of the narrow parcel, present aerial geometry, and recorded dimensions. It may have been newly built, connected, altered, or simply documented in 1934; none of those alternatives is conclusively established.

Construction chronology and placement. The original construction date remains unknown. The 1934 property register records a one-story four-room residential house and a one-story, three-room masonry structure, with penciled dimensions of approximately 13.00 x 7.80 x 3.50 m and 10.00 x 7.80 x 3.50 m. The first footprint, about 101 sq m, closely approximates the present 96 sq m mapped footprint. The narrow parcel and L-shaped aerial roof make a side wing or closely adjoining section more plausible than a detached rear residence. The second section is therefore interpreted as an addition completed, connected, altered, or documented in 1934, but the record does not decide among those possibilities.

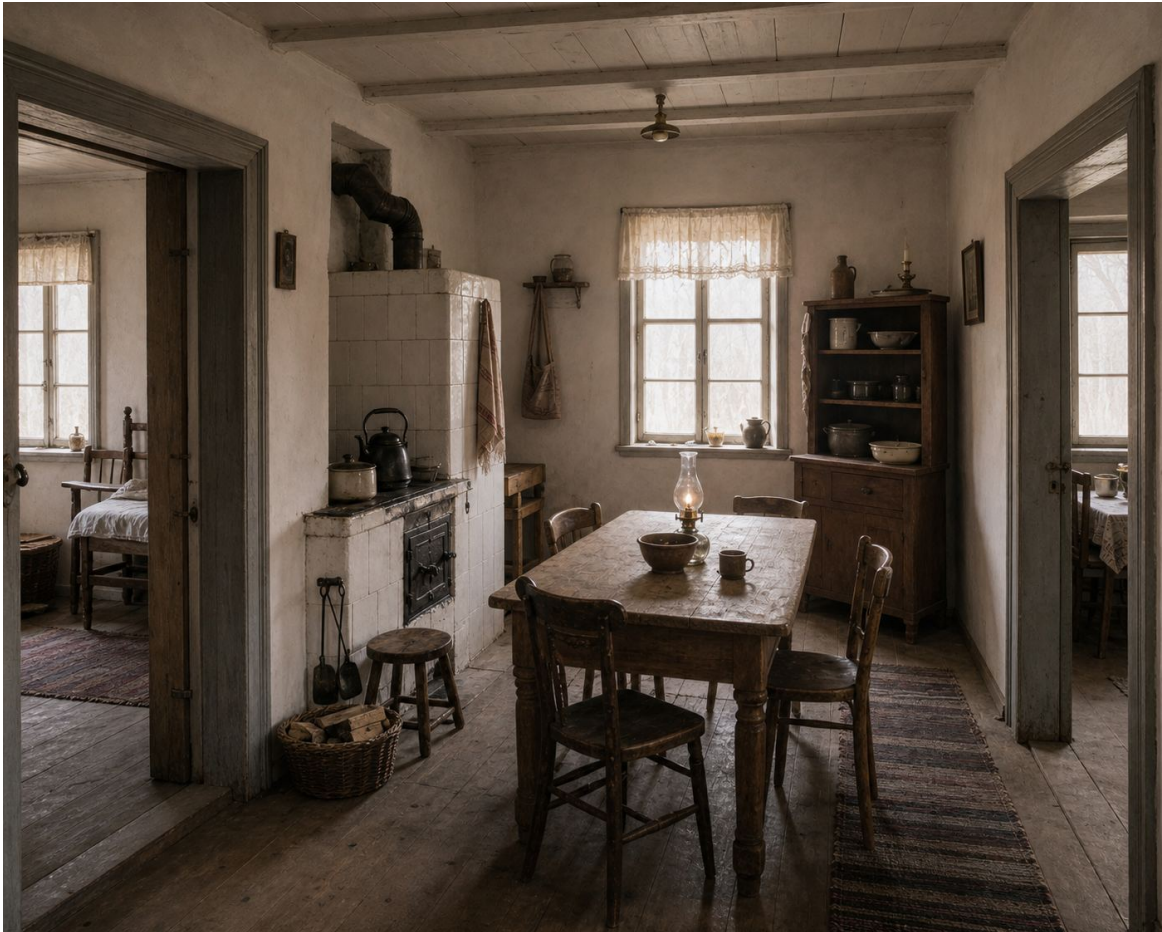
### AI-GENERATED CONJECTURAL RECONSTRUCTION

Conjectural kitchen-dining room in the recorded four-room front house. Doorways suggest a compact, compartmentalized plan; the kitchen may have counted as one historical izba.

No inventory, verified floor plan, or interior photograph has been located. The tiled stove, plank floor, lime plaster, furniture, finishes, and household objects are period-plausible examples, not claims about possessions or the actual layout.

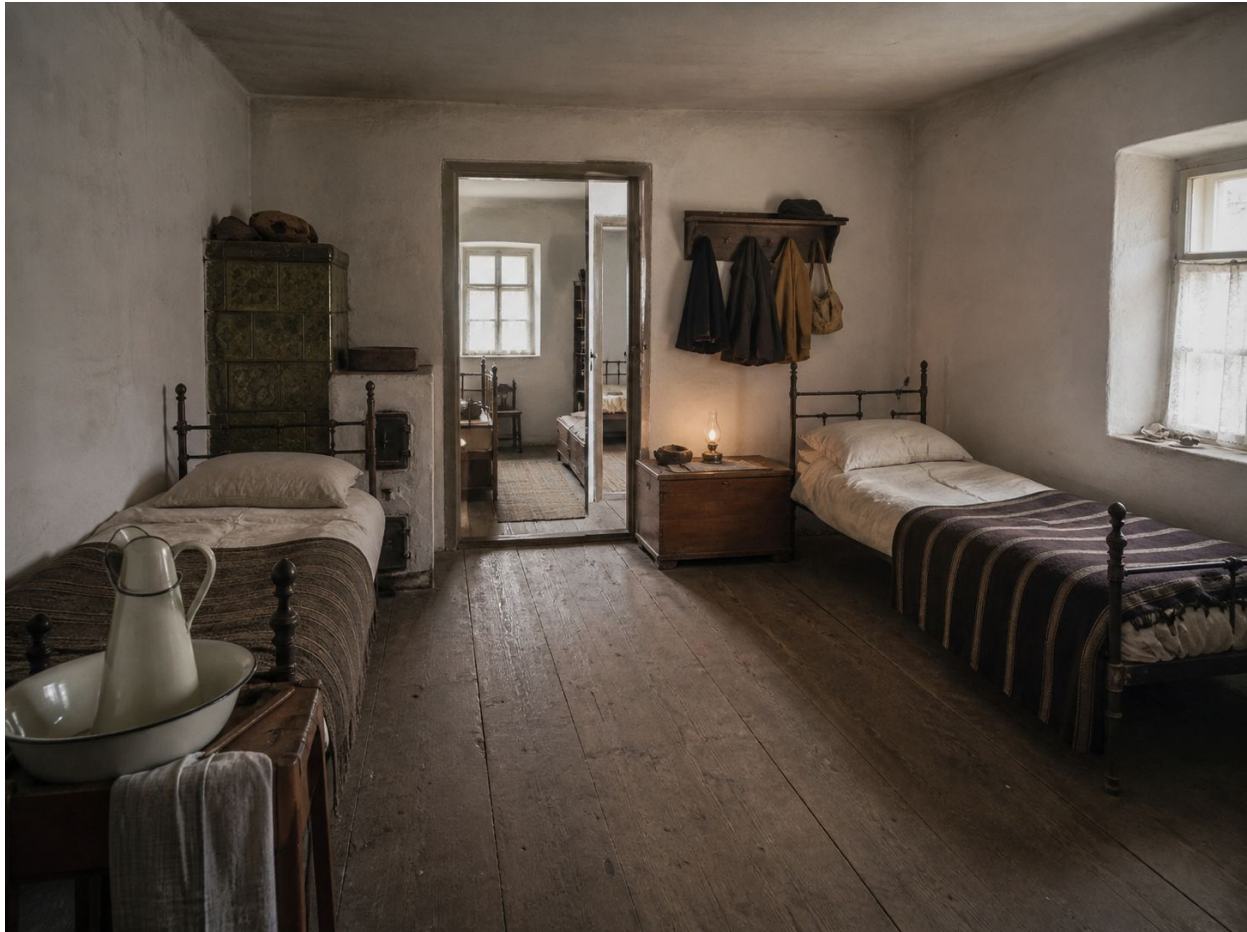
### AI-GENERATED CONJECTURAL RECONSTRUCTION

Conjectural bedroom within the three-room masonry side section. This report assumes that its rooms provided additional family sleeping space and were accessible through a connecting doorway or passage.

The bedroom function is an explicit working assumption. The archival description establishes three rooms and masonry construction, but does not identify their uses or prove that the structure was newly built in 1934.
